Late Infiltration of Post-orthodontic White Spot Lesions

Spätinfiltration von White-Spot-Läsionen nach kieferorthopädischer Behandlung

J Orofac Orthop 2010;71:442–7

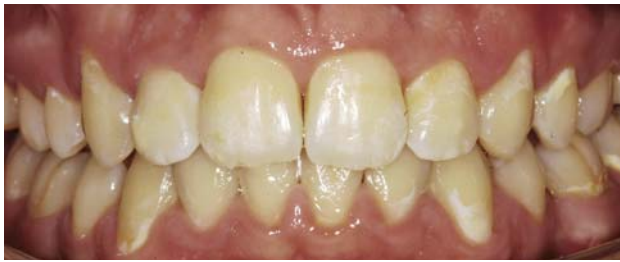
Figure 1. Situation after debonding of the brackets and insertion of a palatal retainer. Upper front teeth are dried out.

Abbildung 1. Situation nach der Entfernung der Brackets und nach Insertion eines palatinalen Retainers. Die oberen Frontzähne sind ausgetrocknet.

Clinical inspection showed WSLs on the labial aspects of teeth 14, 13, 22, 23, 24, 37, 36, 34, 33, 32, 42, 43, 44, and 47 (Figure 1). All WSLs except for tooth 36 were Code 2 according to the International Caries Detection and Assessment System (ICDAS). Only tooth 36 showed local enamel breakdown (Code 3) requiring restorative treatment. The extent of WSLs however was more pronounced on the canines and premolars than on the front teeth.

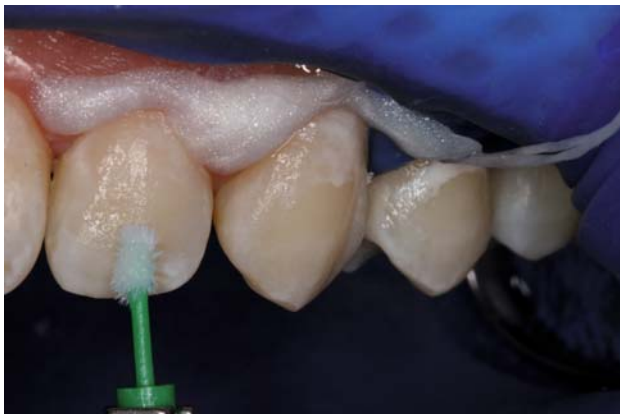
Figure 4. Rewetting with a moist micro-brush mimicks the expected outcome.

Abbildung 4. Das Wiederbefeuchten (Rewetting) mit einer feuchten Microbrush antizipiert das zu erwartende Ergebnis.

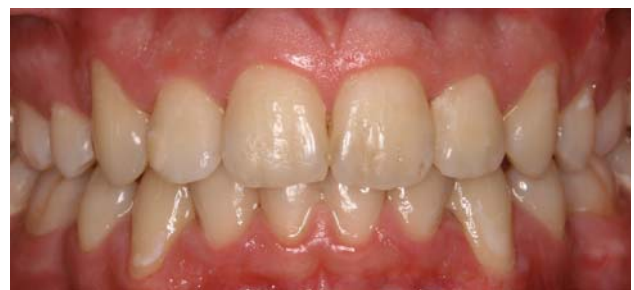
Figure 5. Facial aspect 2 months postoperatively. Generally better appearance, but the severe white spot lesions are still visible.

Abbildung 5. Frontansicht nach 2 Monaten. Das Erscheinungsbild ist generell besser, aber manche Kreideflecken sind immer noch sichtbar.

The treatment was planned separately for the upper and lower jaws. At the first appointment, the upper WSLs were infiltrated. The teeth were isolated with rubber dam. Due to a palatal retainer from canine to canine, the split dam technique was chosen. After gluing the loose dam to the buccal and palatal gingiva with Histoacryl® (Tissue Seal, Ann Arbor, MI, USA), additional gum isolation with Opaldam® (Ultradent, South Jordan, UT, USA) was applied. The teeth were cleaned first with conventional prophylactic pumice (Cleanic; KerrHawe, Bioggio, Switzerland) (Figure 2) and then rinsed and dried. The WSLs were first treated with 15% HCl-gel (Icon; DMG, Hamburg, Germany) for 2 minutes according to the manufacturer's instructions. After thorough rinsing with air-water-spray for 30 seconds the teeth were dried with compressed air. The appearance of the pretreated labial surfaces was chalky (Figure 3). Rewetting with a moist micro-brush was performed to mimic the anticipated outcome. For persisting visible white spots the etching step was repeated once or twice until a favorable outcome could be mimicked (Figure 4). After applying the drying solution (Icon; DMG, Hamburg, Germany) to the surface, it was conditioned for application of the infiltrant (Icon; DMG, Hamburg, Germany). This infiltrant was applied for 3 minutes and then light cured for 40 seconds. The infiltration was repeated once with application of the infiltrant for 1 minute and subsequent light curing for 40 seconds. After infiltration, the surplus was removed using a curette. The tooth surfaces were then polished with a brownie (Shofu, Ratingen, Germany) and with an occlubrush (KerrHawe, Bioggio, Switzerland) using water and light pressure (Figure 5).

unter Wasserkühlung mit nur leichtem Druck poliert (Abbildung 5).
